Manhole Inspection Summary

Manhole # S25C1_012MH

Location Address: **2715 MAISEL ST.**

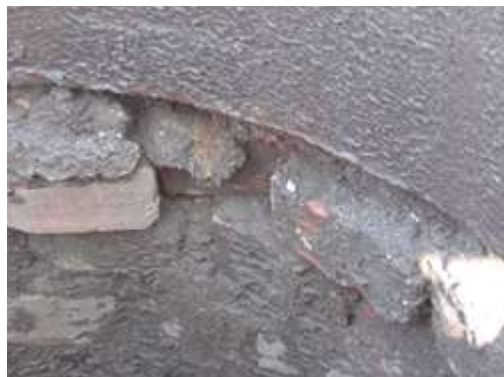
Defect 4

Condition: ☐ Sound ☐ Cracked ☒ **Leaks**

EVIDENCE OF FRAME LEAKING

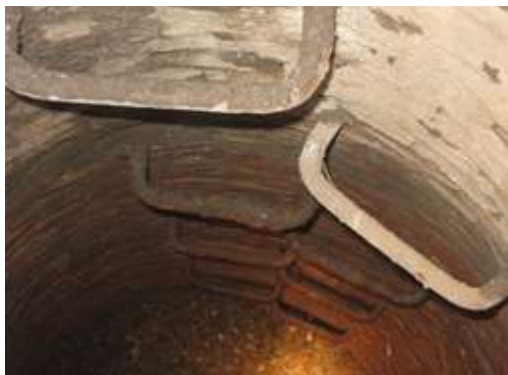
Defect 3

Count: **8** Missing: **0** ☒ **Corroded**

☒ **Evidence Of Surcharge** Depth: **6** (ft.) ☒ **Active Surcharge Present**

steps corroded, surcharge evidence

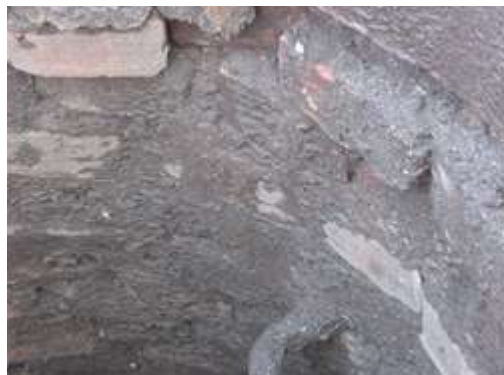
Defect 2

Infiltration: ☐ None ☒ **Joint** ☐ Cracks ☒ **Mortar** ☐ Roots ☐ Wall

Infiltration: ☐ None ☐ Joint ☐ Cracks ☒ **Mortar** ☐ Roots ☒ **Wall**

evidence of flow at chimney joint/mortar & corbel mortar/wall

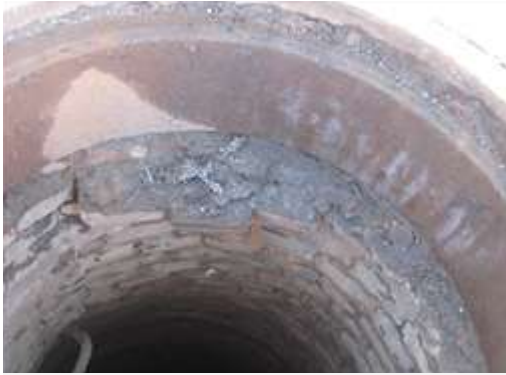
Defect 1

Condition: ☐ Sound ☐ Cracked ☐ Root Intrusion ☒ **Loose Brick** ☒ **Deteriorated**

2 IN FRAME OFFSET, DETERIORATING
AND LOOSE BRICKS IN CHIMNEY,

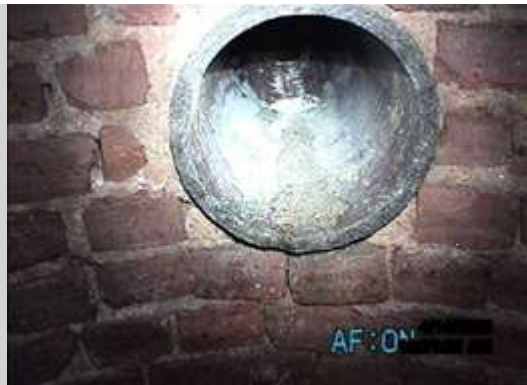
3 O'Clock Inflow

Pipe Height: **8.4** (in.) Rod and Bar (Angled)
Pipe Material: **Clay** ☐ Pipe Lined
Invert Depth: **9.24** (ft.) Flow Characteristics: **None**
Deposits: ☒ None ☐ Mud ☐ Sludge ☐ Debris ☐ Grease
Silt Depth: **0** (in.) Deposits Extent:
Infiltration: **Evidence** Pipe Seal Cond: **Unknown**

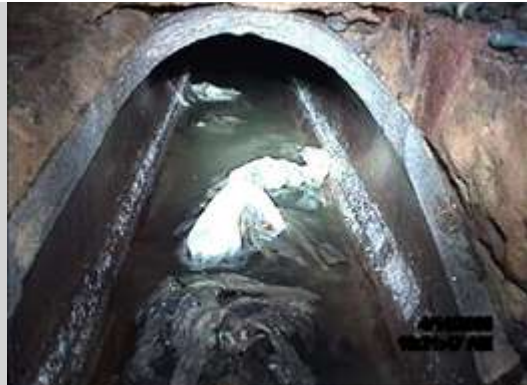
6 O'Clock Inflow

Deposits: ☐ None ☐ Mud ☐ Sludge ☒ **Debris** ☐ Grease

Silt Depth: **4** (in.) Deposits Extent: **Medium**

Infiltration: **Evidence** Pipe Seal Cond: **Unknown**
